## CAVITATION DESTRUCTION OF CONCRETE AND PROTECTIVE FACINGS UNDER NATURAL CONDITIONS

Yu. P. Inozemtsev

In 1963 a field inspection was made of the condition of the concrete in the lower pool of the dam of the V. I. Lenin Volga hydroelectric station.\* Unlike previous years, besides the energy dispersion baffles an investigation was made of condition of the concrete of the spillway face, piers, bottom of the stilling pool, and first subsidiary dam of the third section, which was dewatered for repair for the first time after 7 years of service.

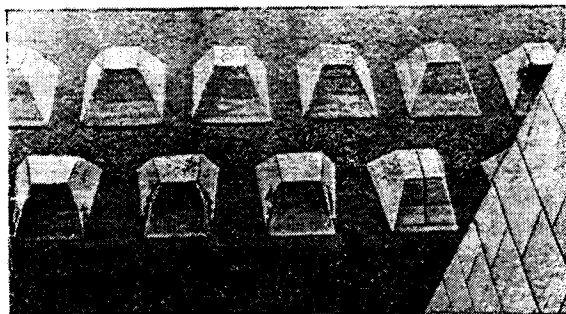
Destruction of the upper and front faces of the deflecting baffles and dissipation baffles of the first row was quite insignificant (Figs. 1, 2, and 4). The dissipation baffles of the second row were in much better shape; erosion of the side faces was rare and small in area, but in the overwhelming majority (about 80%) the front face was eroded. The erosion zone extended over the entire width of the face; it began at a height of 0.5-1 m from the base of the dissipation baffle and had a height of 0.3-0.4 m, with uniform wear to a depth of 2-5 cm. The character of destruction differed from the cavitation destruction on the side faces of the dissipation baffles: the aggregate was exposed but not torn out, roughnesses were smoothed out, and there were no cavities, which were characteristic for the cavitation zone on the side faces.

Fig. 1. Cavitation destruction of energy dissipation baffles. View from the dam crest (the baffles of the first row located in the middle of the span were subjected to greatest damage).

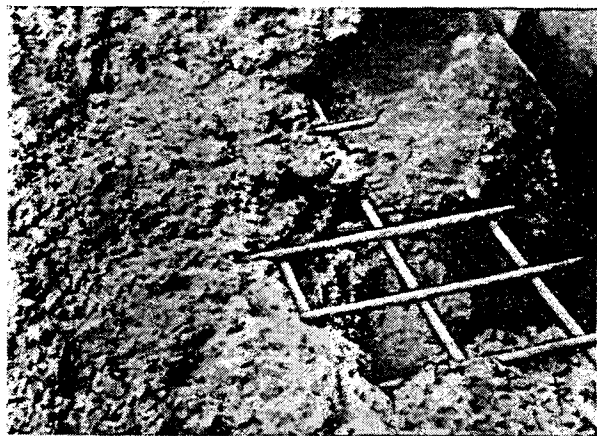
Fig. 2. General view of destruction on side face of energy dissipation baffle of first row.

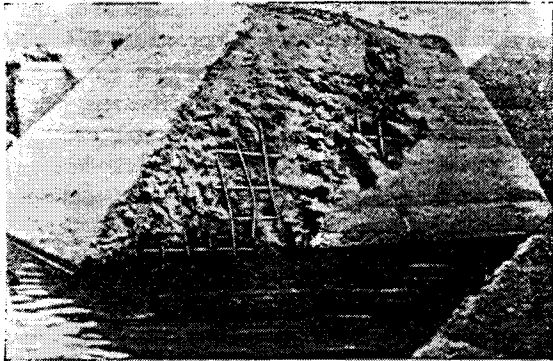
Fig. 3. Fragment of cavitation zone of concrete on side face of energy dissipation baffle.

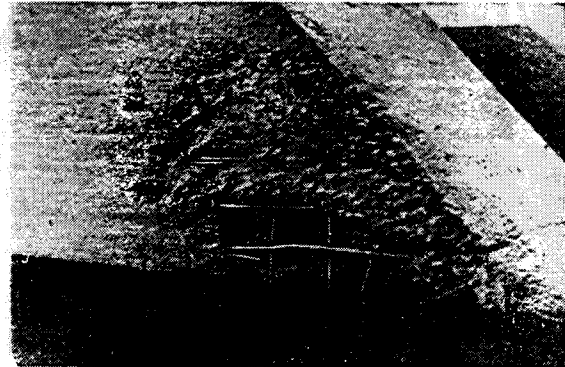
Figure 4 shows cavitation destruction of the concrete on the side face of the deflecting baffle. Cavitation occurred when the current flowed from right to left past the edge between the front (inclined) face and the destroyed face of the deflecting baffle. The erosion zone extended up 2/3 of the side face. The depth of erosion was not constant over the entire zone. Erosion of maximum depth occurred at the site of a poorly made (as a consequence

of interruption during concreting) joint, which was indicated by a horizontal crack clearly seen on both sides of the eroded surface and outcropping on the front and second side face. This joint proved to be the weakest section on the side face of the dissipation baffle due to weak adherence of the new concrete to the old. Here the deepest erosion occurred. The same photograph demonstrates the decrease in resistability of the concrete to cavitation where the reinforcement rods are placed. This example shows that in those places of concrete structures where cavitation is expected to take place it is necessary to pay particular attention to the placement of high-quality concrete and appropriate control of the concrete hardening conditions, and the thickness of the protective layer should be increased as opposed to the standard 3-5 cm.

Fig. 4. Cavitation erosion on side face of deflecting baffle.

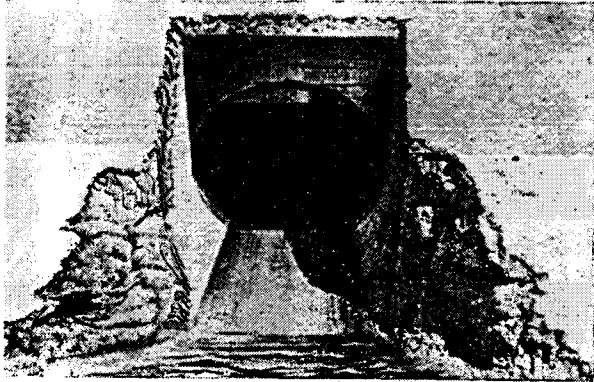
Fig. 6. Cavitation destruction of concrete of the junction between the outlet portal of the deep conduit and spillway face.

The experiment of using steel facing to prevent cavitation erosion of concrete on the Miranda Dam (Portugal) is interesting and instructive [15]. At this 80-m-high dam considerable cavitation of the concrete occurred of the junction between the outlet portal of the deep conduit and spillway face during eight months of service (Fig. 6), when only the crest spillway was operating. Cavitation was an unexpected event for the designers and builders. Control model investigations of this component in the laboratory confirmed the occurrence of cavitation and development of erosion of the concrete (Fig. 7). On the basis of this it was decided to change the geometry of the junction component and use a metal facing of 10-20 mm steel sheet. The facing and the general view of the junction after repair are shown in Fig. 8. Such repair was done twice, but each time the facing was ripped away and the concrete severely eroded (Fig. 9).

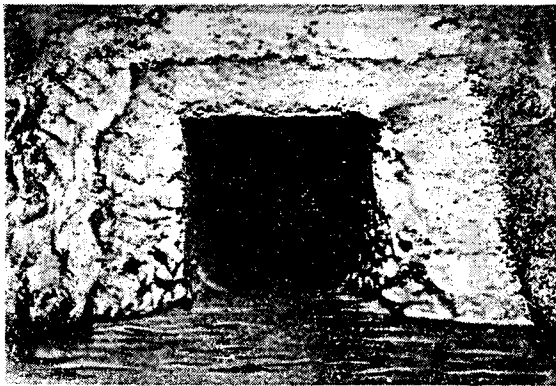
Fig. 7. Cavitation erosion of concrete of a model of the junction.

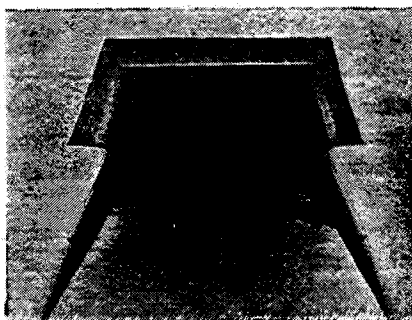
Fig. 8. General view of faced junction between outlet portal of deep conduit and spillway face.

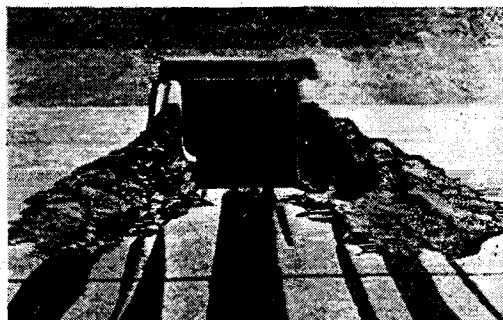
Fig. 9. Erosion of faced junction after passage of one flood.
